## Des Moines Laboratory

### Blood Culture Bottles Imperfections:

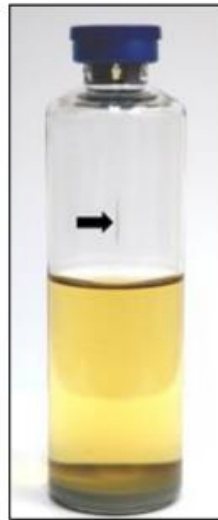
**Figure 1**

White seam line visible in the side of the plastic bottle. This vertical line may be hidden beneath the bottle label or may extend the length of the bottle to above and/or below the label. It does not impact the function of the bottle.

Biomeriux has a new bottle manufacturer that may produce blood culture bottles that have some imperfections. These are purely cosmetic and do not affect the performance of the testing.

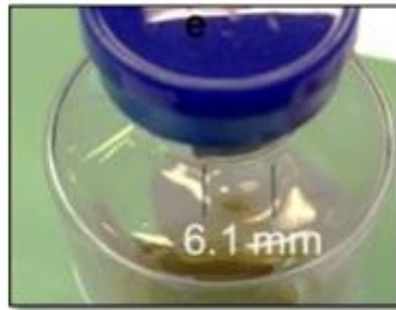
**Figure 2**

Wave/bubble in the neck of the plastic bottle that is less than or equal to 10 mm in diameter. It does not impact the function of the bottle.
